INSTALLATION
RESTORATION PROGRAM

PHASE I - RECORDS SEARCH

ROBINS AFB, GEORGIA

APRIL, 1982

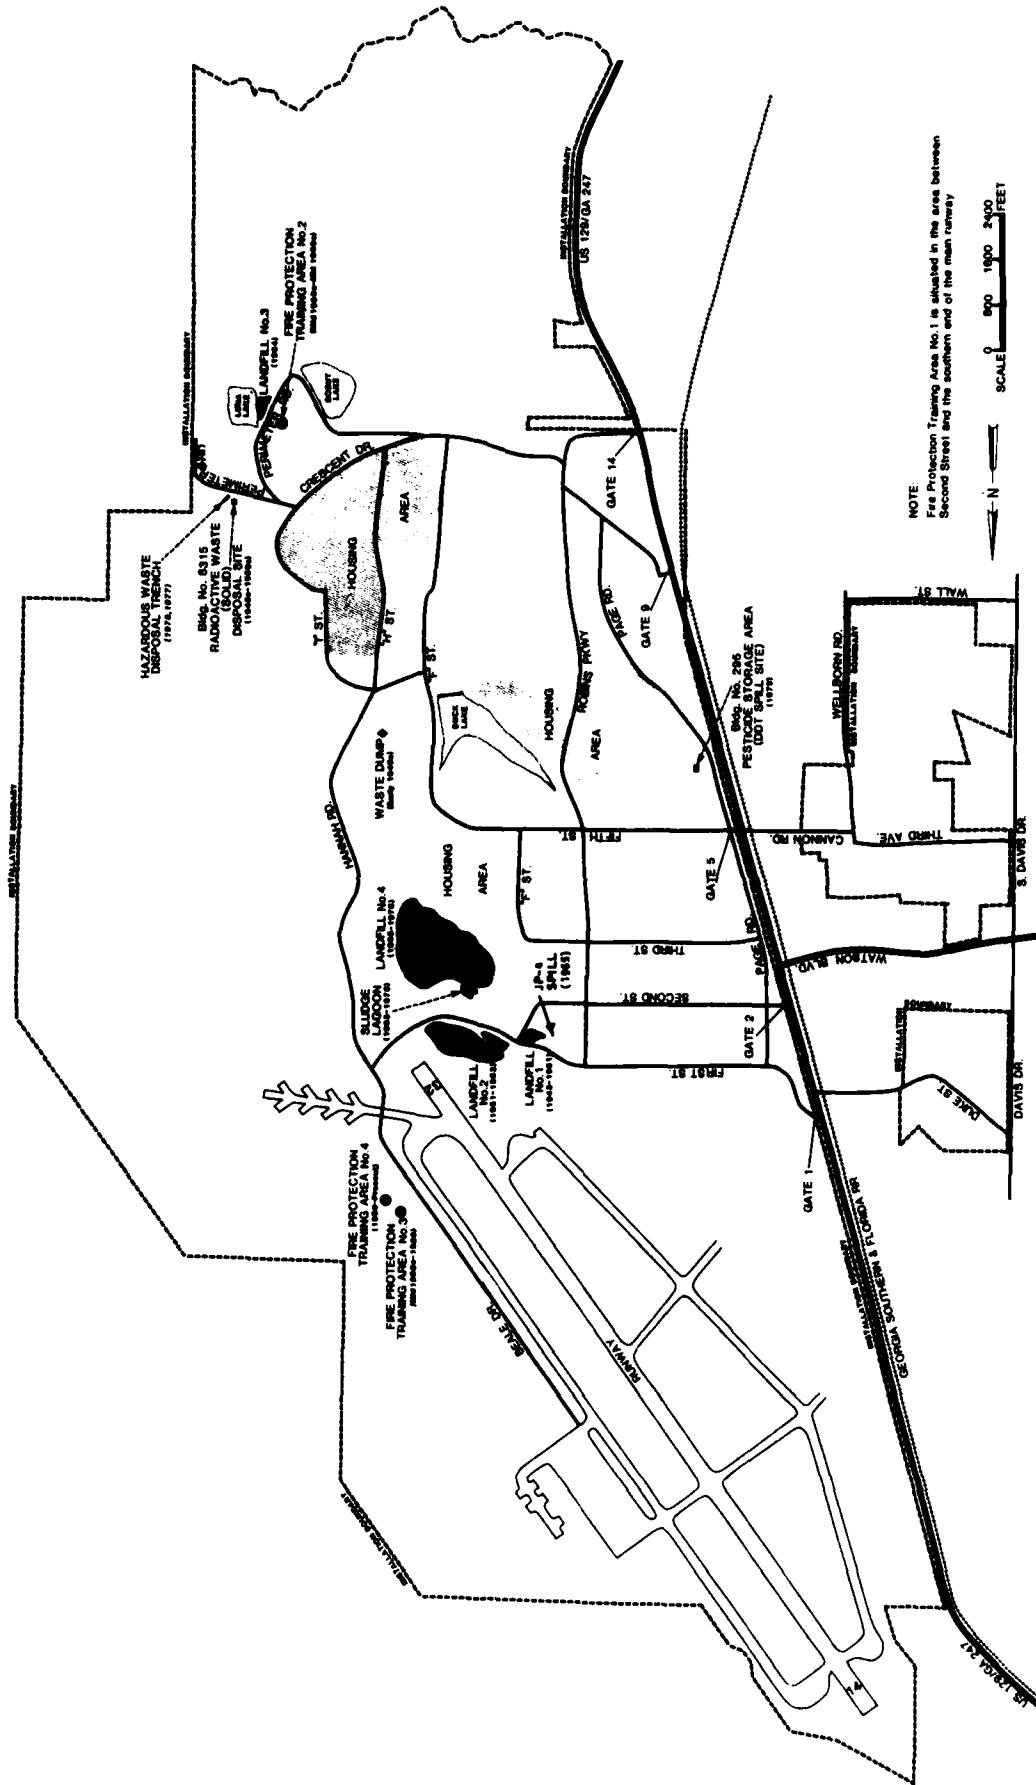
FIGURE 1

stored, and disposed of hazardous waste. Thirteen disposal sites located on the Robins AFB property were identified as containing hazardous waste resulting from past waste disposal activities, (Figure 1). These sites have been assessed using a hazardous assessment rating methodology (HARM) which takes into account factors such as site characteristics, waste characteristics, potential for contaminant migration and waste management practices. The details of the rating procedure are presented in Appendix E and the results of the assessment are given in Table 1. The rating system is designed to indicate the relative need for follow-on action. *Review and data of further development of potential contaminant migration are included.*

ROBINS AFB SITES WITH POTENTIAL FOR CONTAMINANT MIGRATION

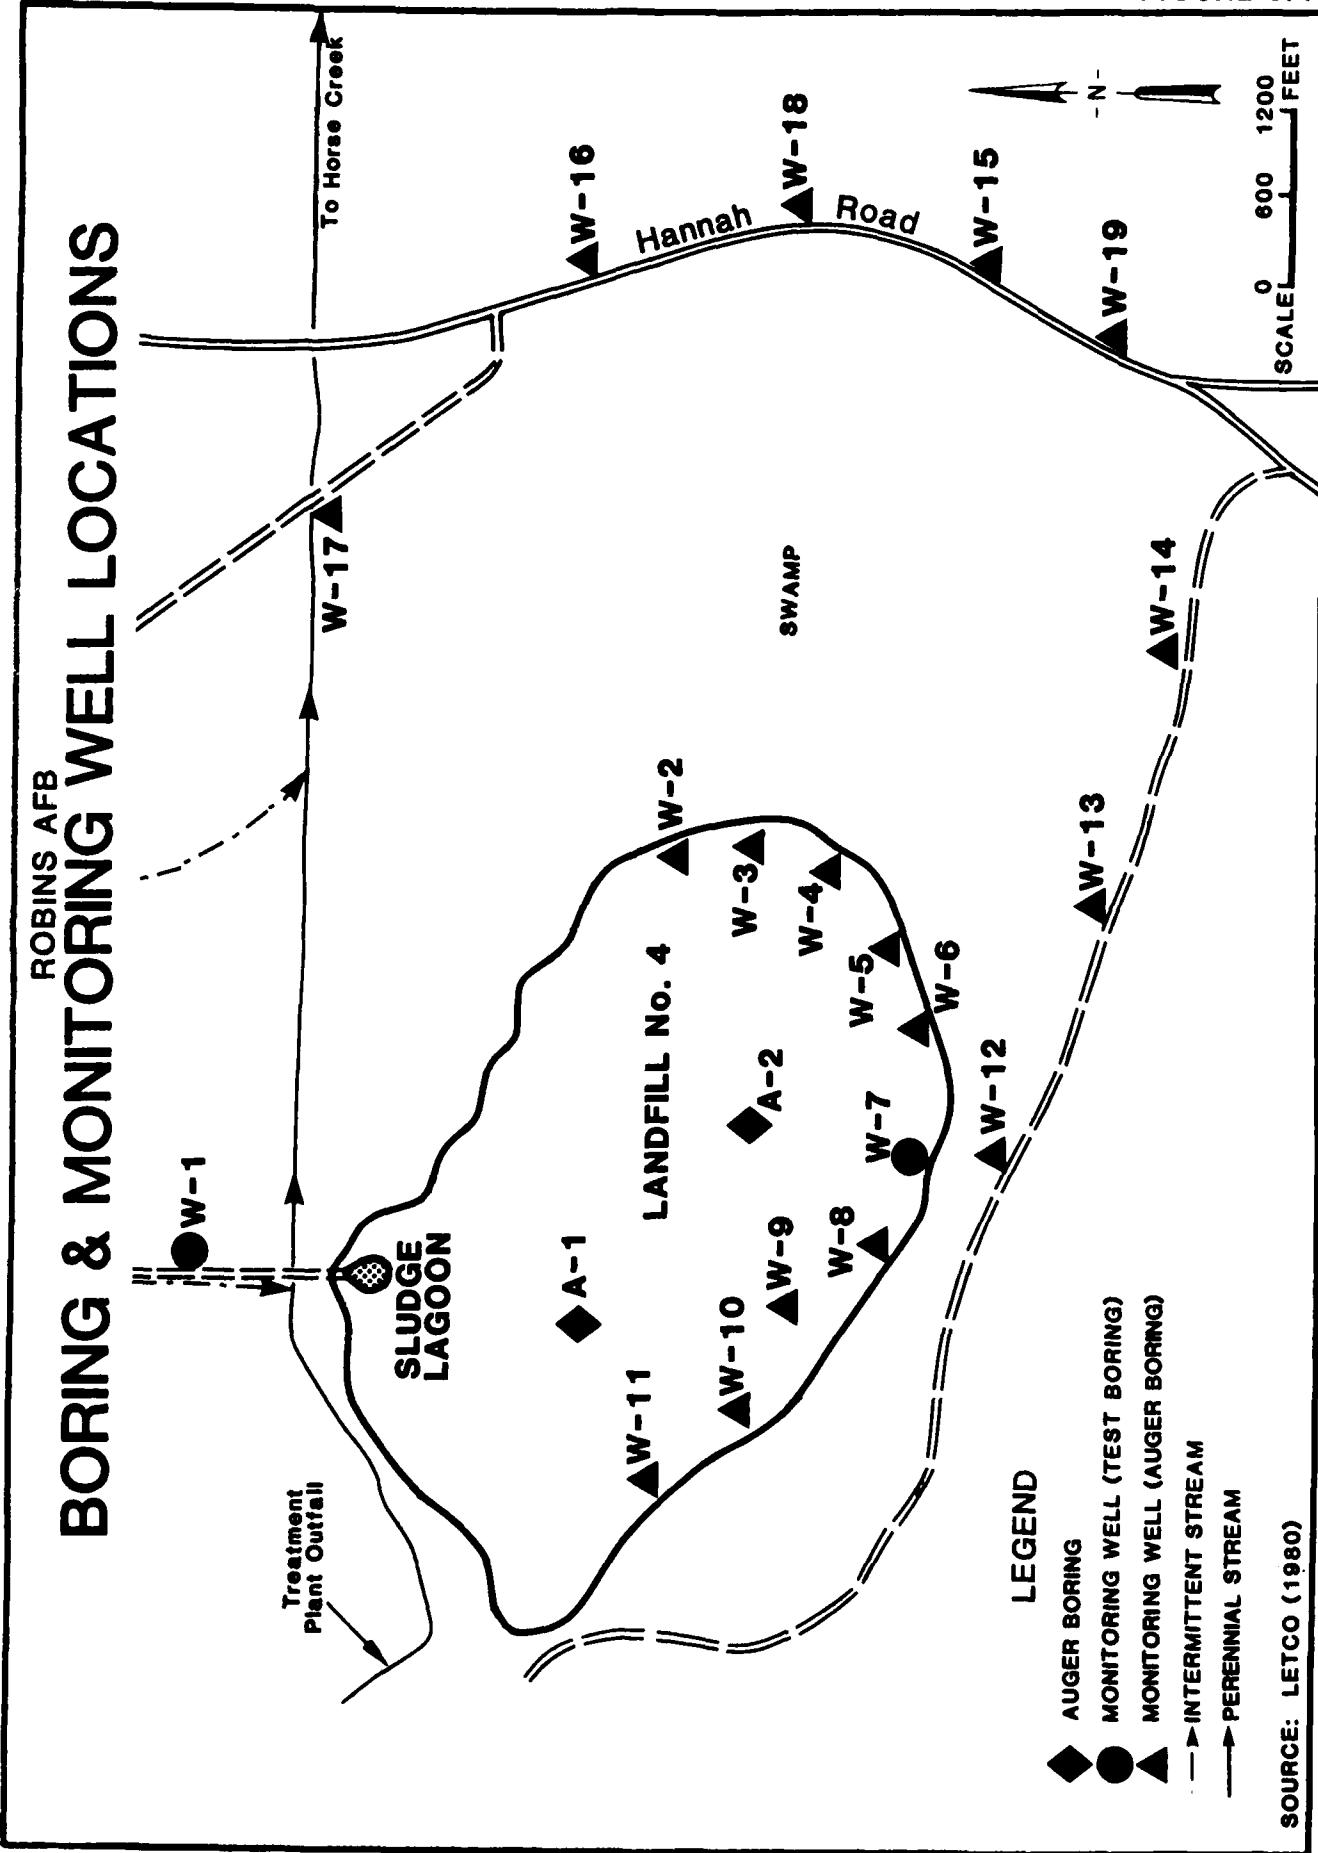
FIGURE 3.10

ROBINS AFB BORING & MONITORING WELL LOCATIONS

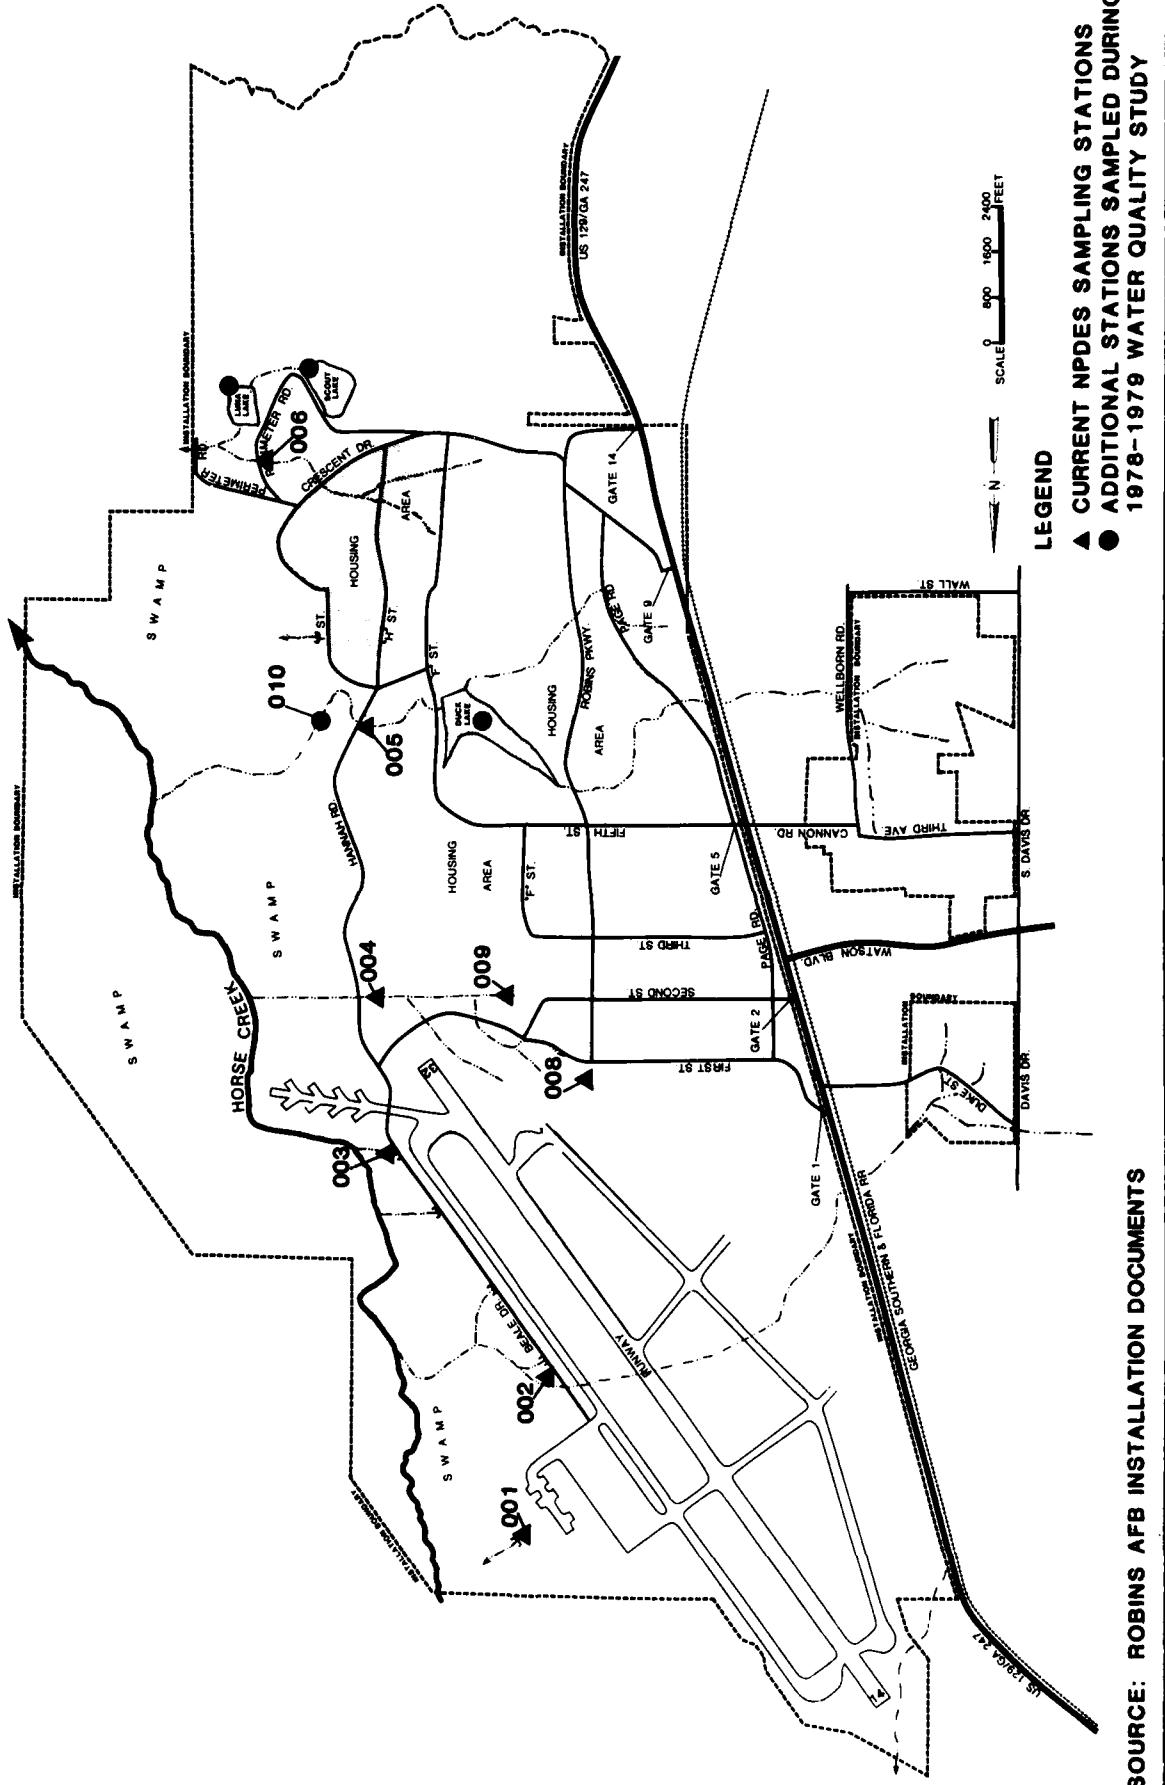
FIGURE 3.11

(Talley, et al., 1979). Figure 3.11 depicts the surface water monitoring stations presently sampled for NPDES permit compliance as well as the additional stations sampled during the 1978-1979 baseline survey. Summaries of the data compiled during the 1978-1979 study and the 1981 NPDES data are included in Appendix C.

All remaining monitoring stations were found to have good water quality values. The only noticeably high constituent detected was total iron in samples collected from Stations 001 and 005 during the 1978-1979 survey. These concentrations ranged from 0.28 to 3.4 mg/l for Station 001 and 0.57 to 1.8 mg/l for Station 005.

ROBINS AFB SURFACE WATER QUALITY MONITORING STATION LOCATIONS

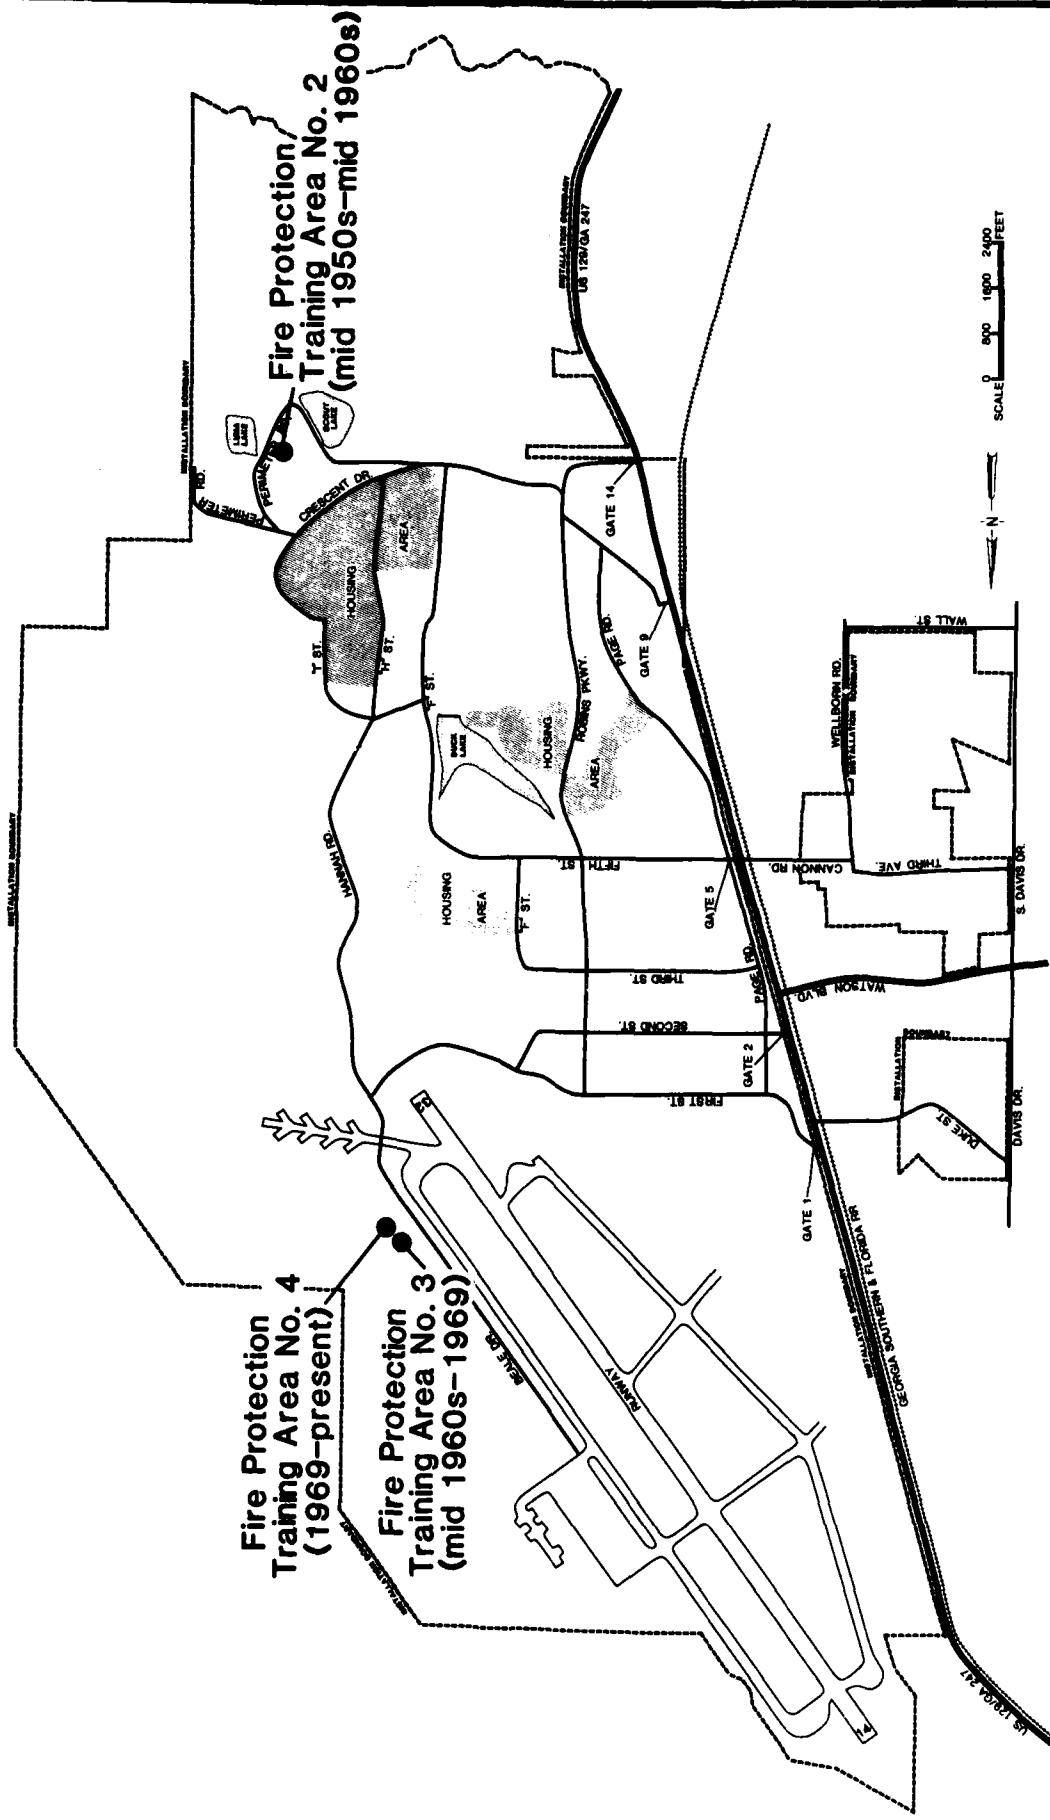
FIGURE 4.1

ROBINS AFB
FIRE PROTECTION TRAINING AREAS

NOTE: FIRE PROTECTION TRAINING AREA NO. 1 IS SITUATED IN THE AREA BETWEEN SECOND STREET AND THE SOUTHERN END OF THE MAIN RUNWAY

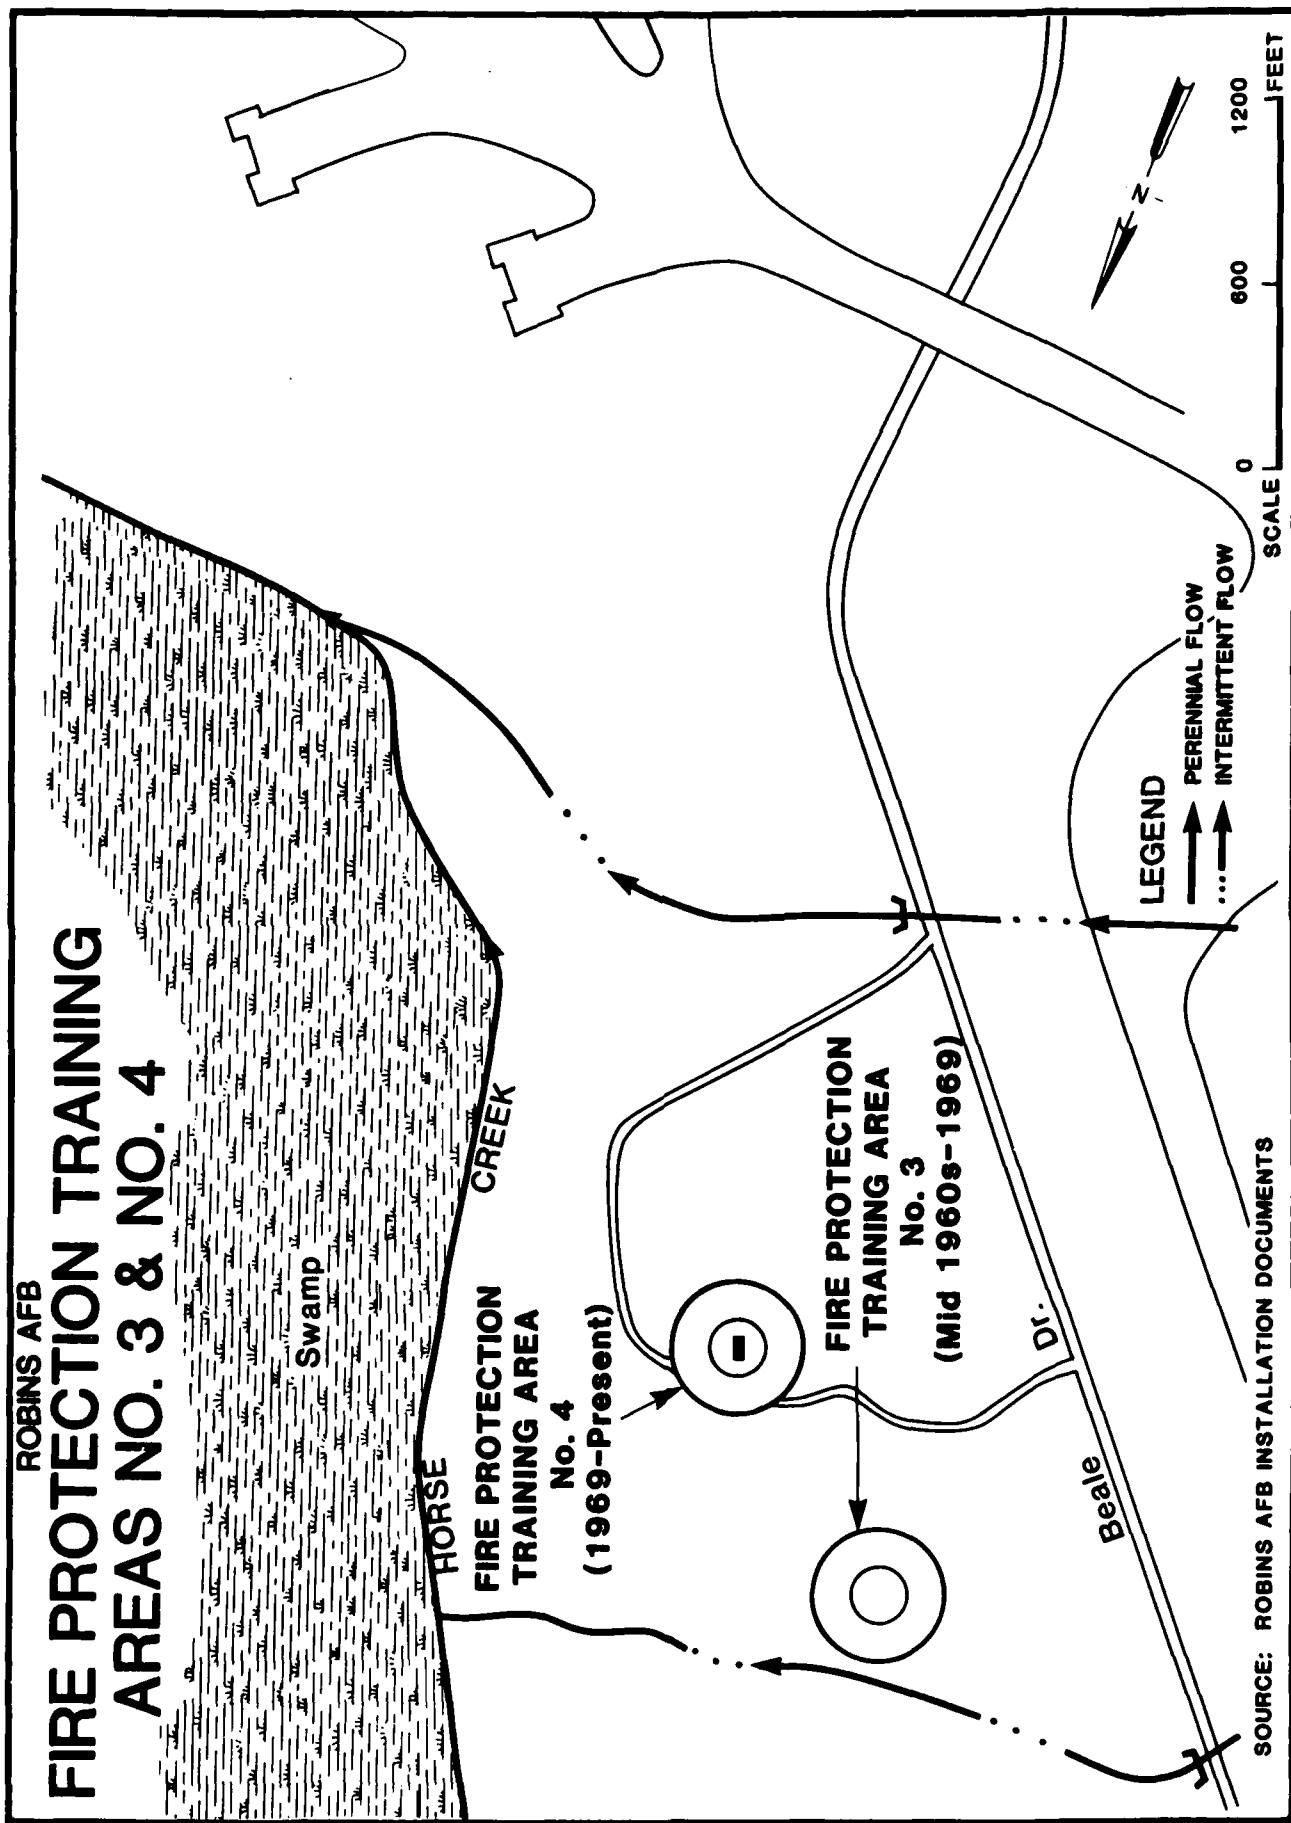
FIGURE 4.3

Fire protection training area No. 3, was another diked, unlined pit. This area was located close to the present site (No. 4), as shown in Figure 4.3. The site was operated from the early 1960's until the construction of the present training area in 1969. As previously mentioned, air pollution regulations curtailing the number of exercises and requiring the use of only uncontaminated fuel became effective during this period.

The current site, fire protection training area No. 4, is a concrete lined, diked pit located in the SAC area as shown in Figure 4.3. Permanent fuel tanks with gravity feed were also installed during construction. Training exercises are limited to twice per quarter using uncontaminated JP-4.

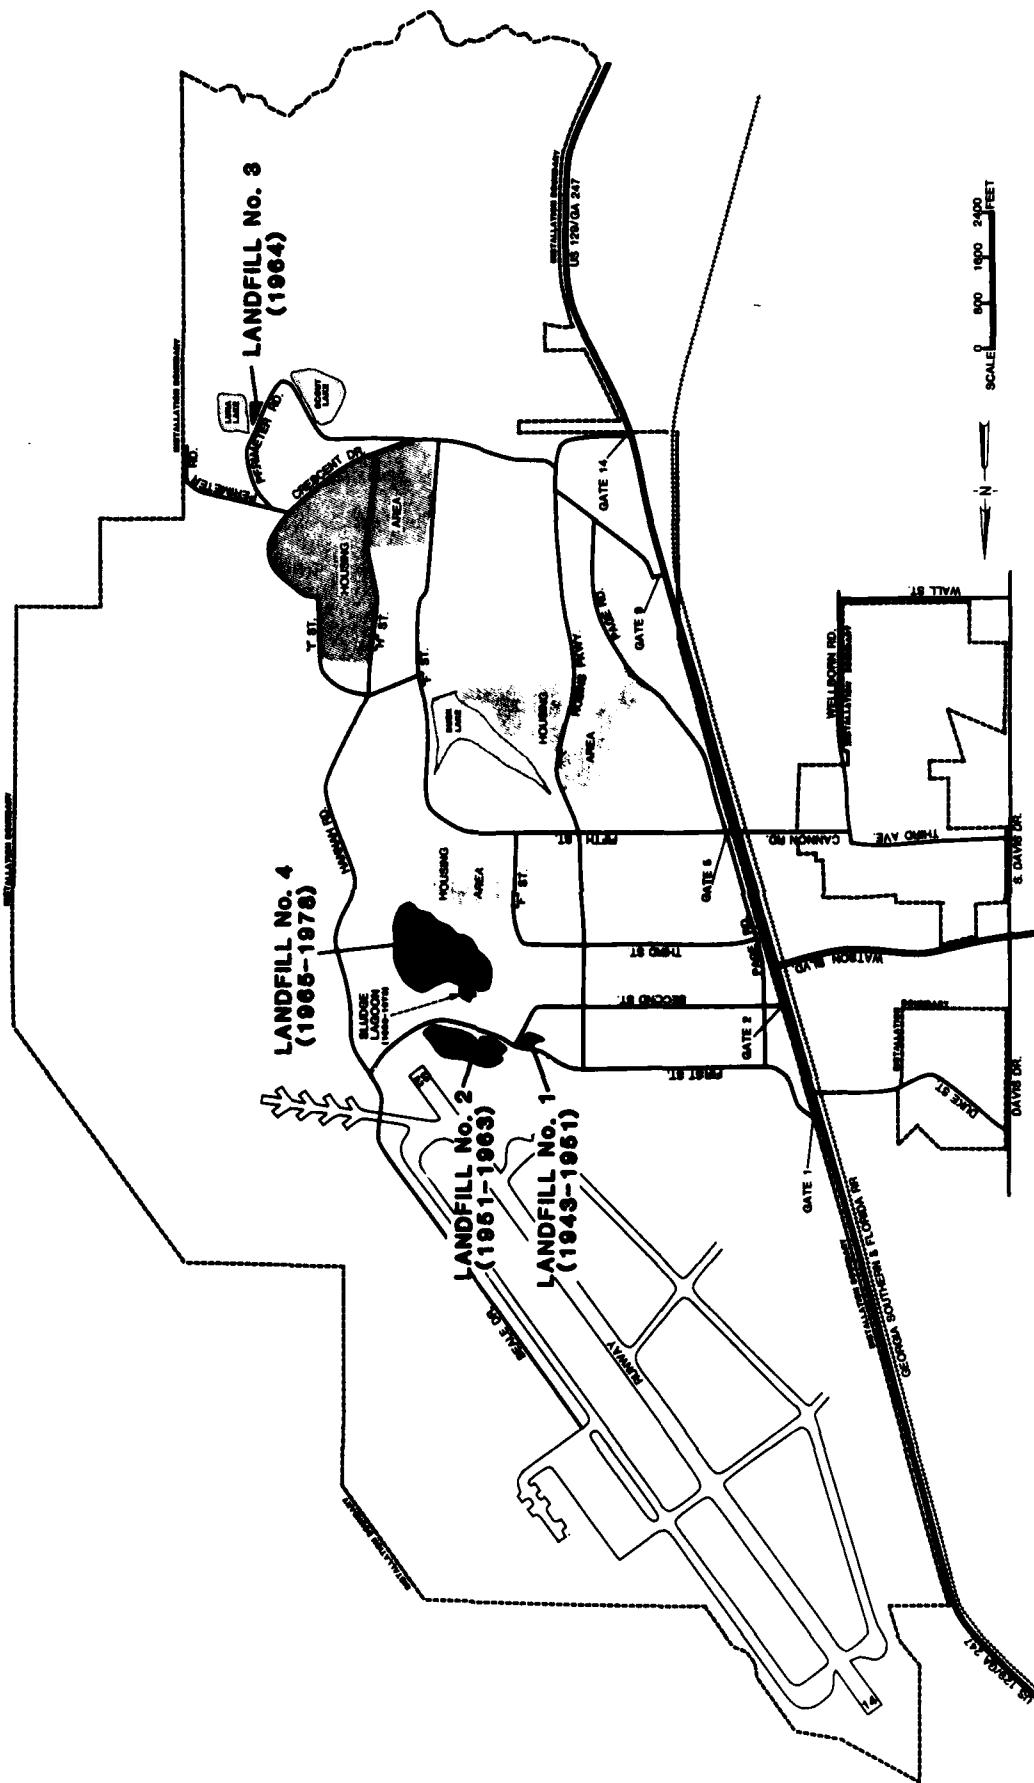
FIGURE 4.5

On-base landfills have been used for disposal of non-hazardous and hazardous solid wastes at Robins Air Force Base. Landfills were operated at four locations on the base as shown in Figure 4.5. Table 4.3 contains a summary of pertinent information concerning each landfill disposal site. Since 1978, solid wastes have been hauled off-base and no landfills were operated on the base.

ROBINS AFB LANDFILL LOCATIONS

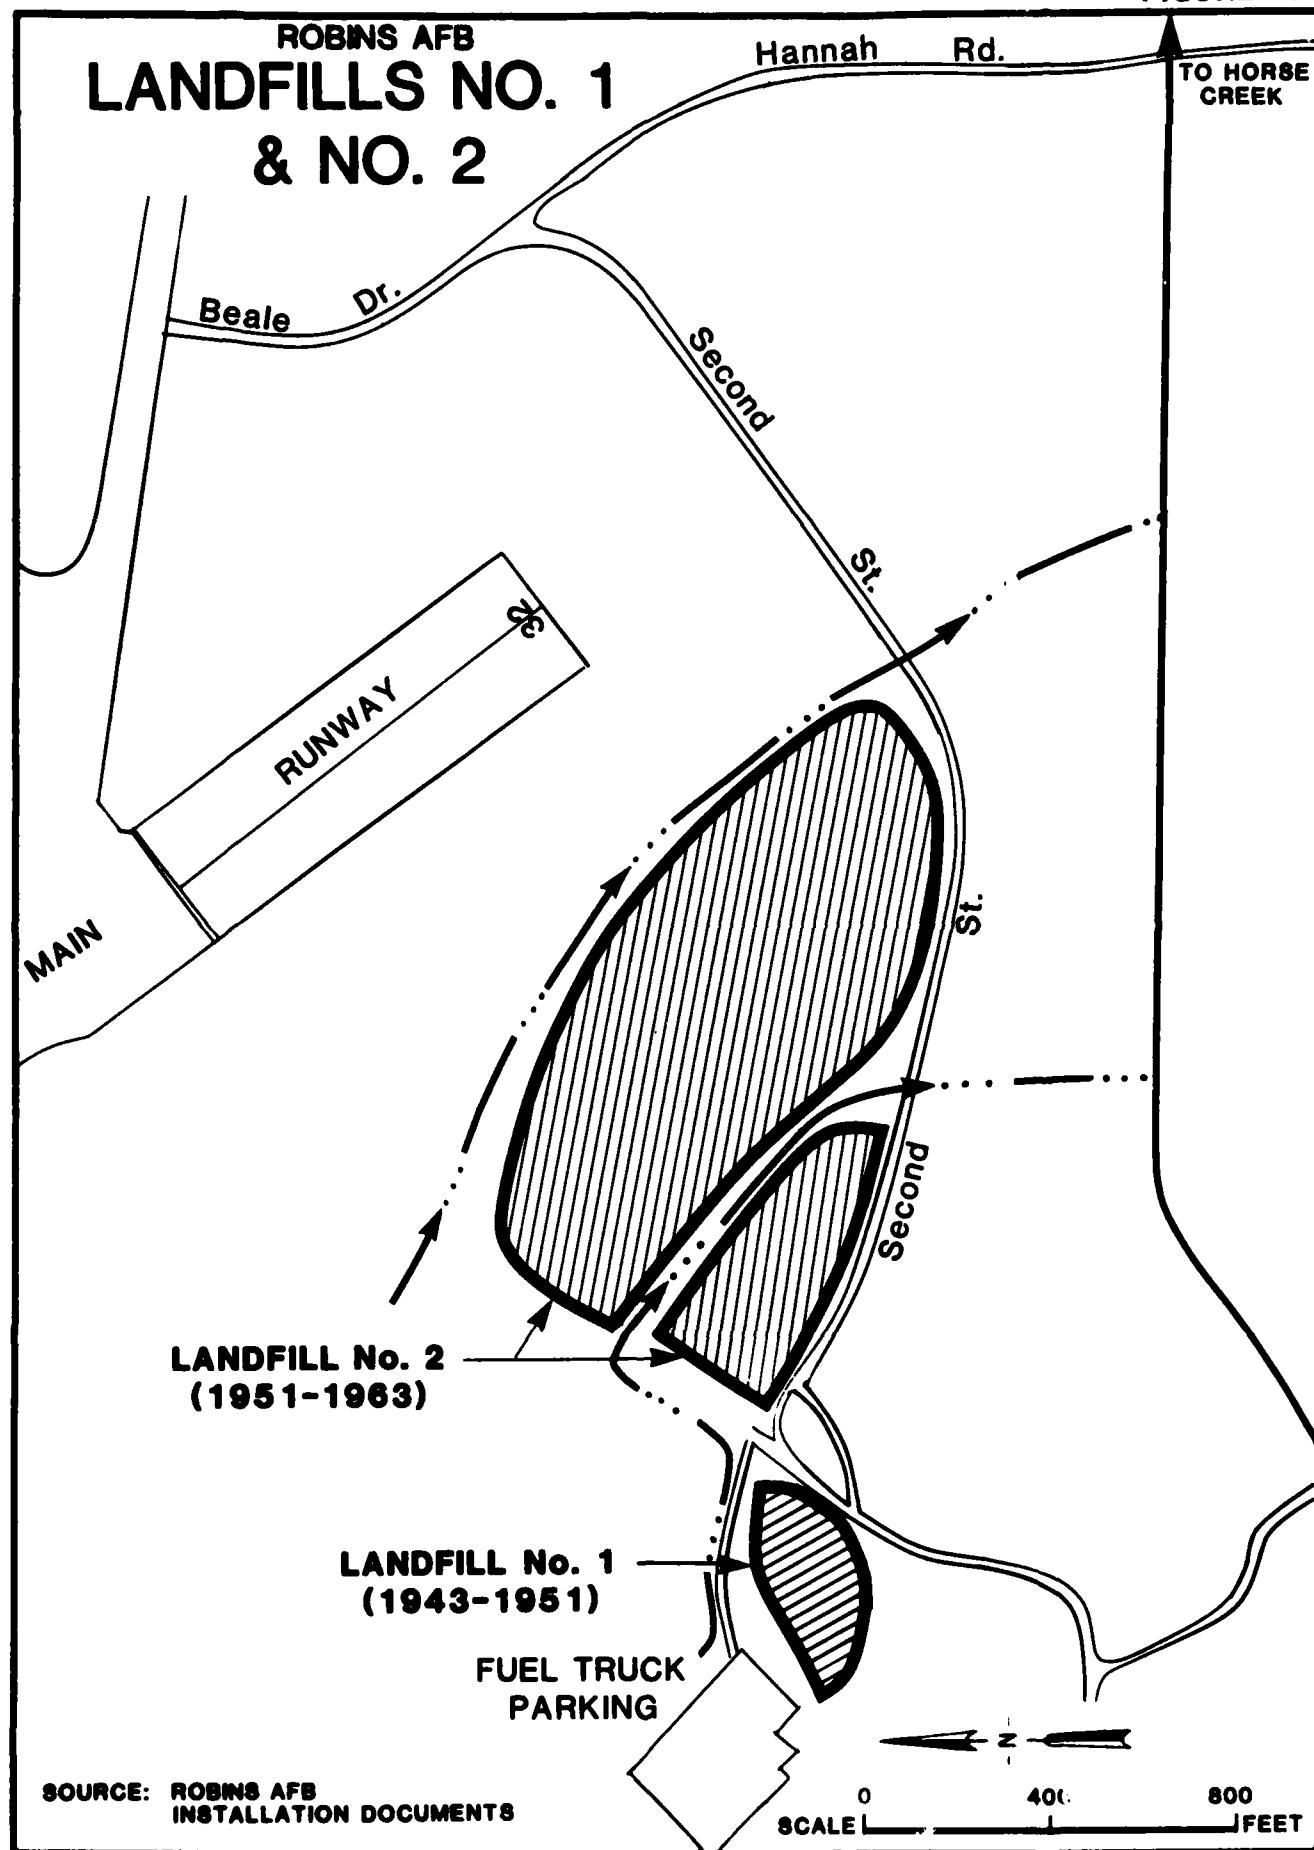
FIGURE 4.6

Landfill No. 1 is located, as shown in Figure 4.6, near the south end of the runway, between the fuels management (POL) tank farm and Second Street. The site was operated from 1946 to 1951, encompassing an

area of approximately two acres. The landfill was a trench and fill operation with daily cover of bottom ash from the boiler. The area had been previously filled with a sandy loam. Trench depths of 20 feet penetrated the fill material and sometimes extended below the water table requiring pumping when equipment had to operate near the trench bottom. General refuse from the base and housing areas was the primary material landfilled. Disposal of chemicals in the landfill was not standard procedure, however, some industrial wastes may have been placed in this landfill. An impact test facility sled was constructed on the site after landfill was closed. During construction of the sled, JP-4 seeped into the excavation that had been dug in the landfill. The source of the fuel may have resulted from a previous leak in the 4-inch diameter fuel supply line. Apparently, portions of the landfill contained JP-4 from the leaking supply line. The landfill is closed and the area is covered with soil and has established grass. During visual inspection of the site a green colored leachate was noted flowing from an eroded section on the northwest slope of the landfill. The site is 800 feet from a drinking water well and 4500 feet from the base boundary.

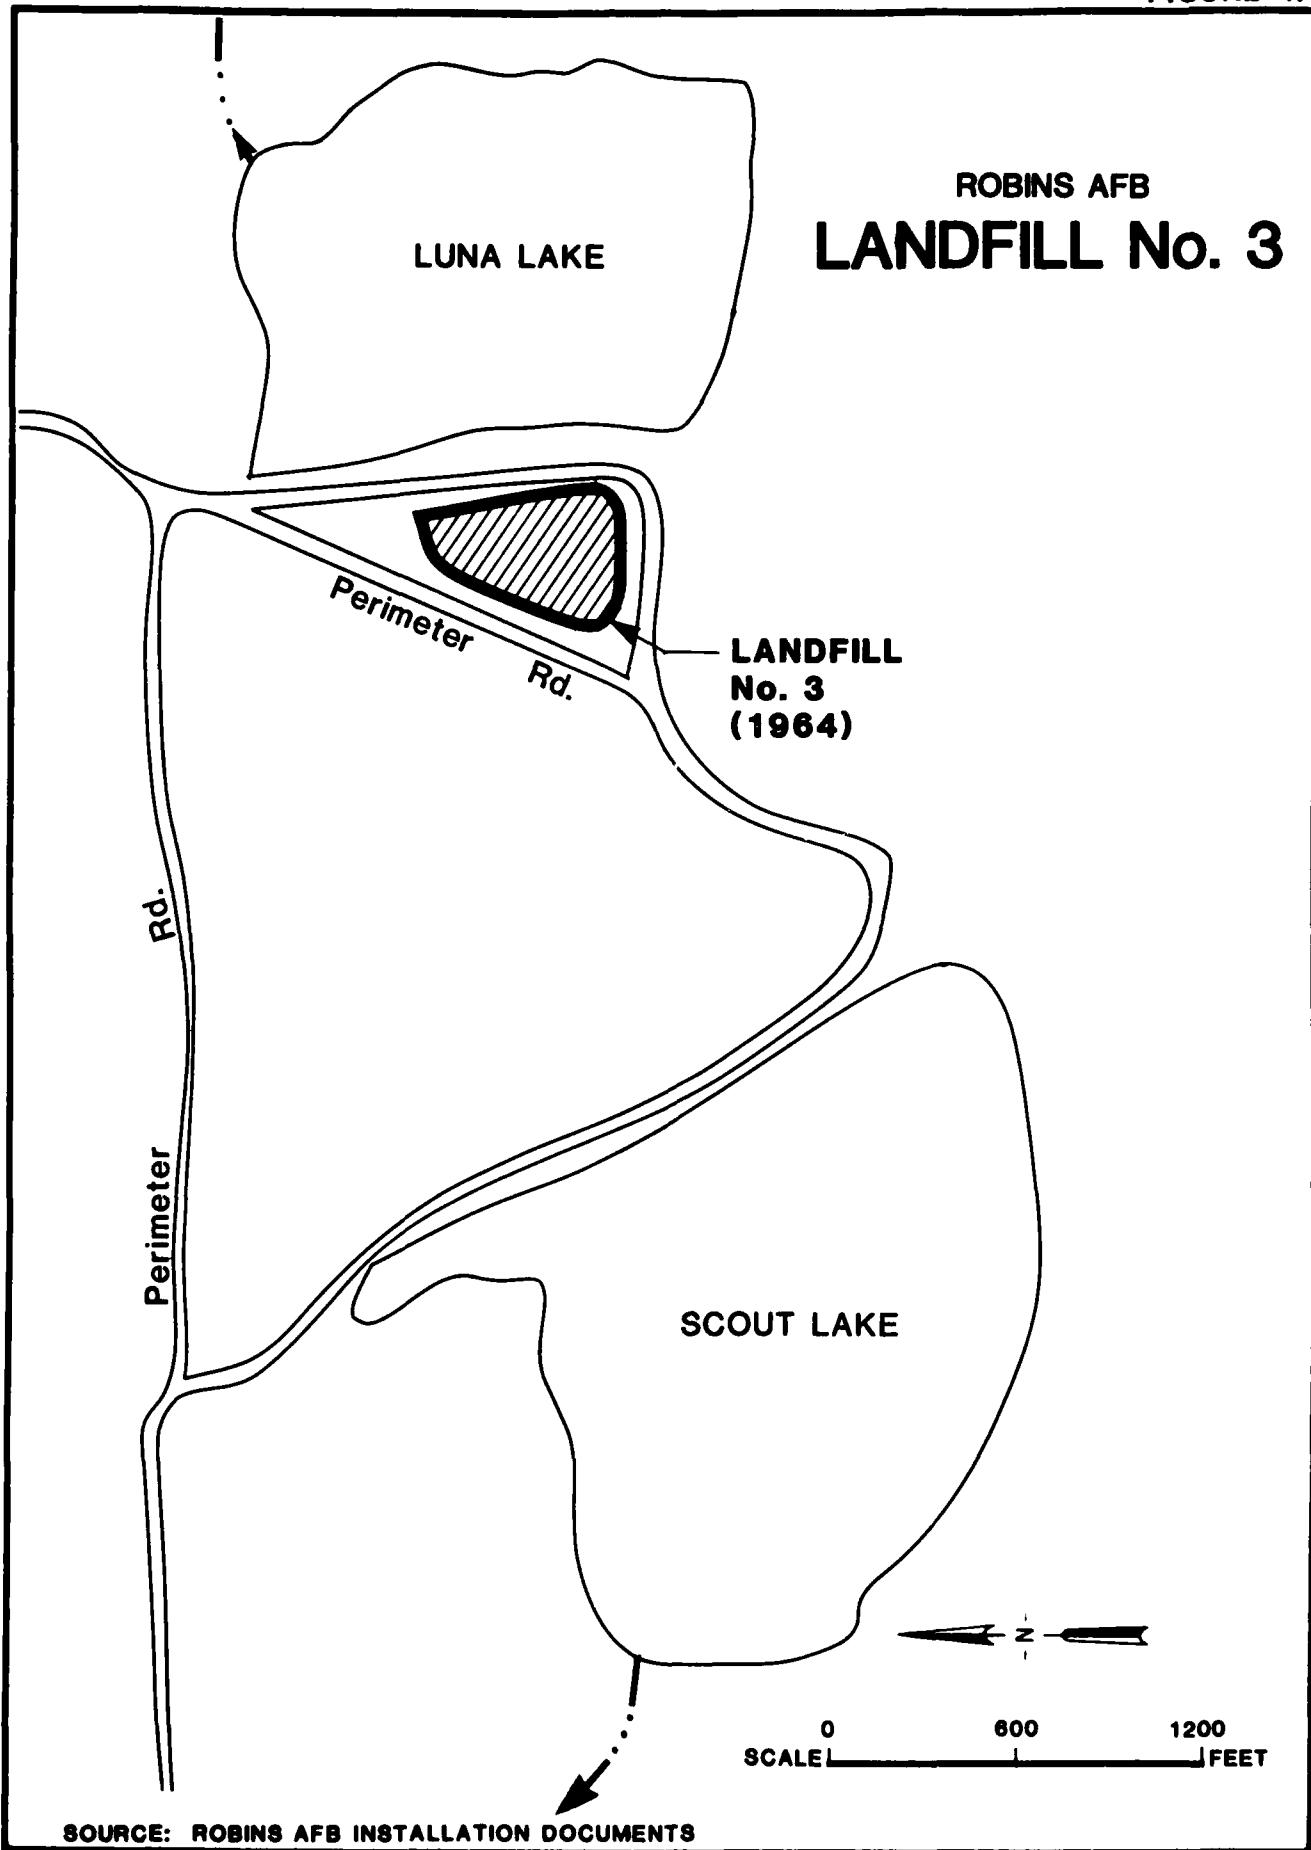
FIGURE 4.7

Landfill No. 3 is located, as shown in Figure 4.7, in the south-eastern part of the Robins AFB property near Lake Luna. The site was operated in 1964, primarily to fill a swampy area. Total area of the fill is approximately 2 acres. General refuse was deposited followed by a daily cover of sandy loam. Fire protection training exercises were conducted around the landfill site. The landfill is closed and the area has an established vegetation cover and a baseball field is built over it.

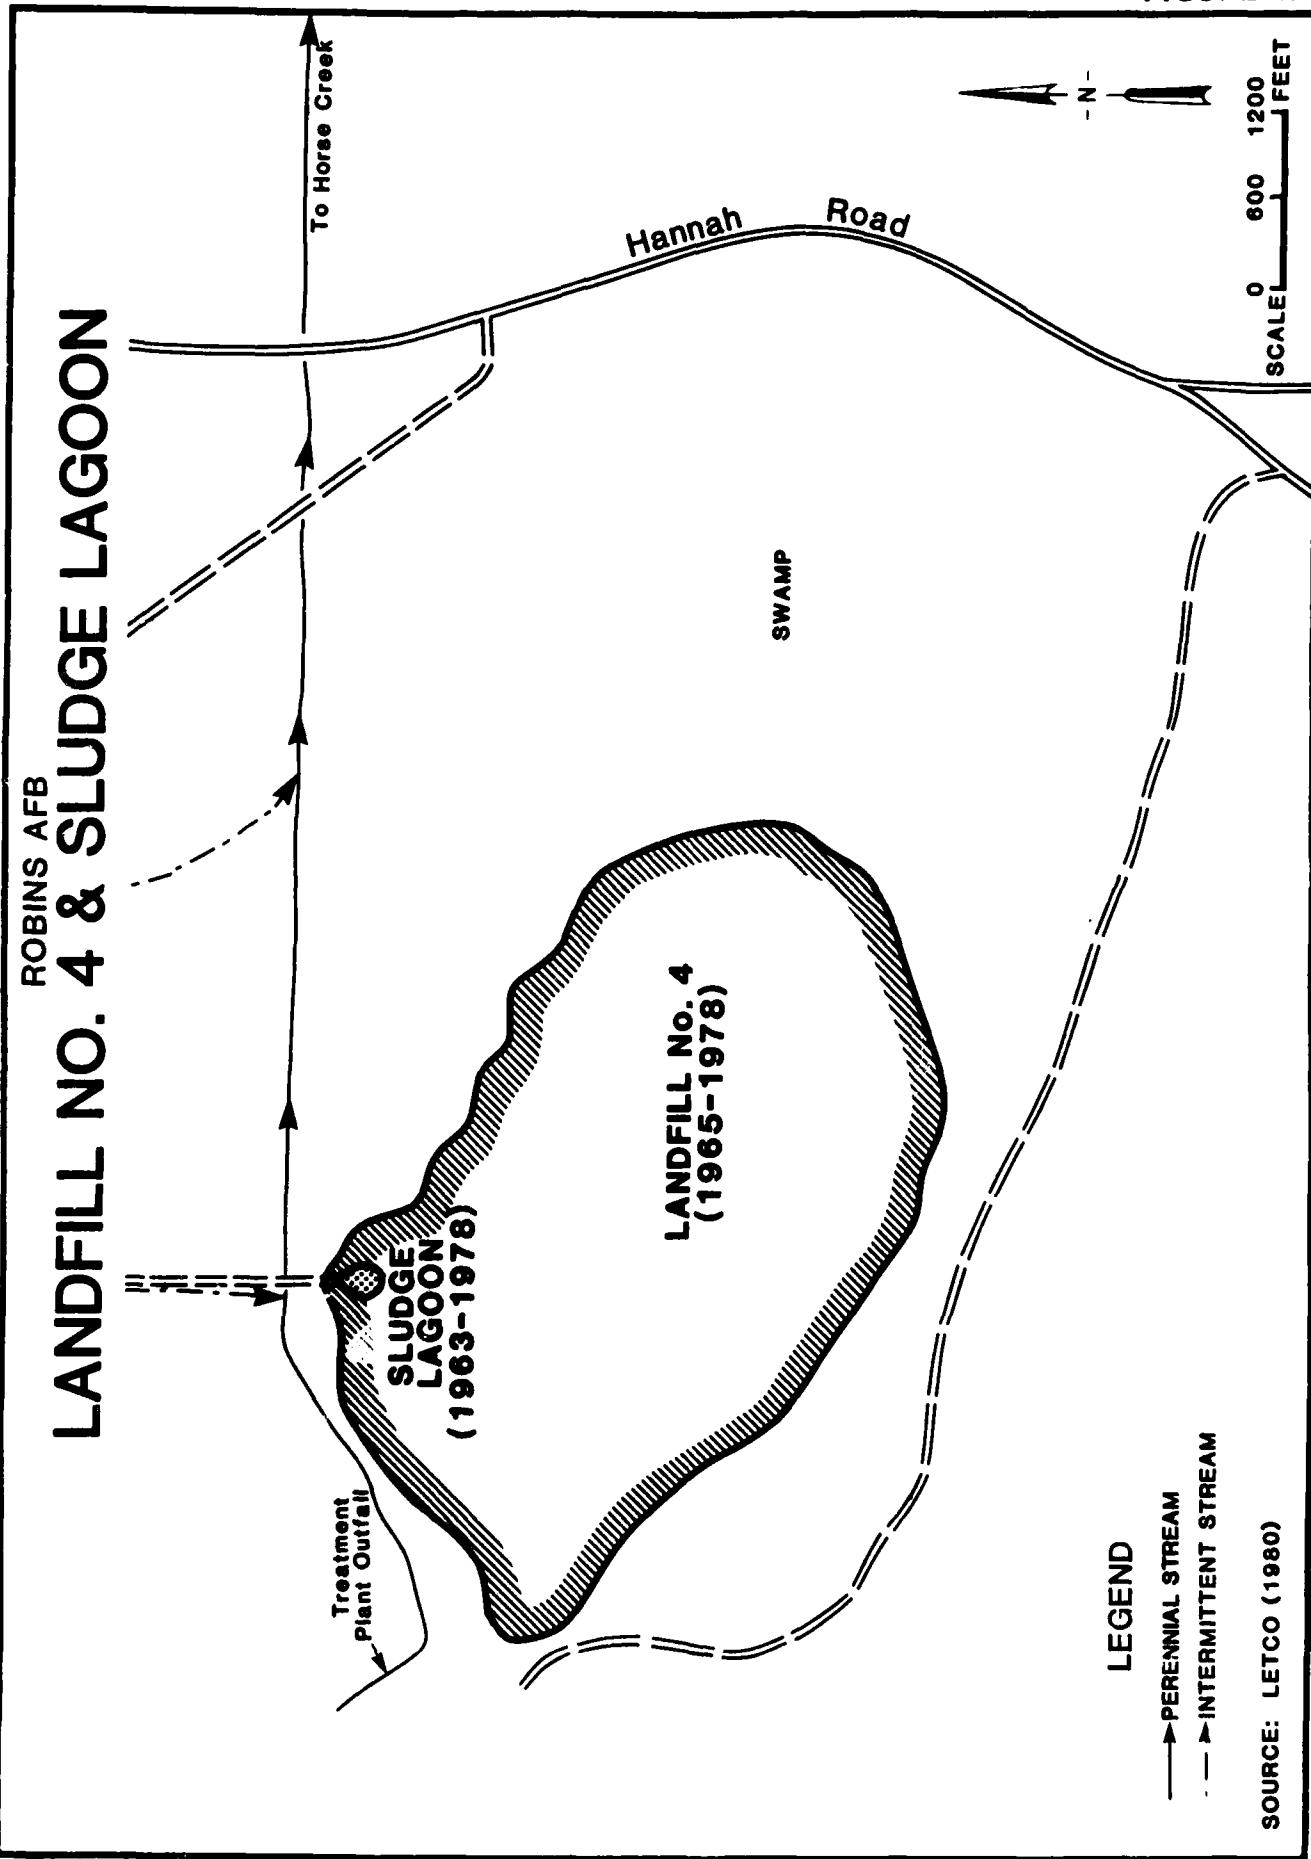
FIGURE 4.8

Landfill No. 4 is located, as shown in Figure 4.8, near landfill No. 2, southeast of the industrial waste treatment plant addition. The fill was operated from 1965 to 1978, encompassing approximately 45 acres. Landfill No. 4 was the last on-base disposal site for solid waste. General refuse was deposited into the swamp and covered daily with a sandy soil. Little or no boiler bottom ash was used as cover due to the conversion of the boiler system to natural gas in 1966. There was occasional dumping of industrial wastes in this landfill throughout its life. The site is now covered with a sandy soil loam and partially established vegetation. This site is approximately 2200 feet from a drinking water well and is located adjacent to drainage ditches which flow to Horse Creek. From 1976 to 1979, approximately 1500 drums of waste material were stored at the west end of the landfill. A ground-water monitoring study was conducted around Landfill No. 4 and the sludge lagoon (LETCO, 1980). The results of this monitoring program indicate the presence of contaminants in the shallow aquifer has occurred downgradient of the site.

A sludge lagoon was used for disposal of industrial wastewater treatment plant sludges from approximately 1962 until its closure in 1978. The lagoon encompassed approximately 1.5 acres located on the north end of Landfill No. 4 (Figure 4.8). The lagoon was an unlined, diked pit with the bottom excavated below the water table level.
